# Manhole Inspection Summary

Manhole # S04CC2011MH

**Location** Address: **3501 CROSS COUNTRY BLVD** Cross Street: **LABYRINTH RD**

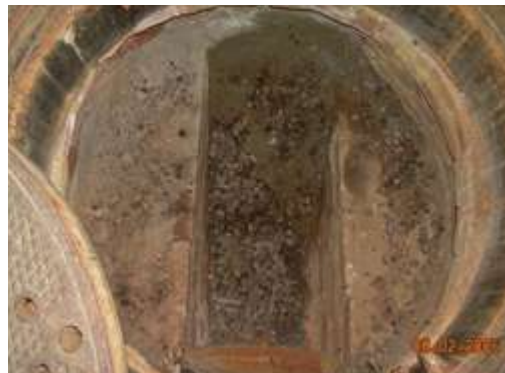
Top View

**Corbel** Material: **Brick** ☐ Parged Type: **Concentric/Eccentric**  
Condition: ☒ Sound ☐ Cracked ☐ Root Intrusion ☐ Loose Brick ☐ Deteriorated  
Infiltration: ☐ None ☒ **Joint** ☐ Cracks ☒ **Mortar** ☐ Roots ☐ Wall

**Barrel** Material: **Brick** ☐ Parged  
Shape: **Circular** Diameter: **42** (in.) Length: (in.)  
Condition: ☒ Sound ☐ Cracked ☐ Root Intrusion ☐ Loose Brick ☐ Deteriorated  
Infiltration: ☐ None ☐ Joint ☐ Cracks ☒ **Mortar** ☐ Roots ☒ **Wall**

Corbel and Barrel infiltration. Bench debris. Channel debris.

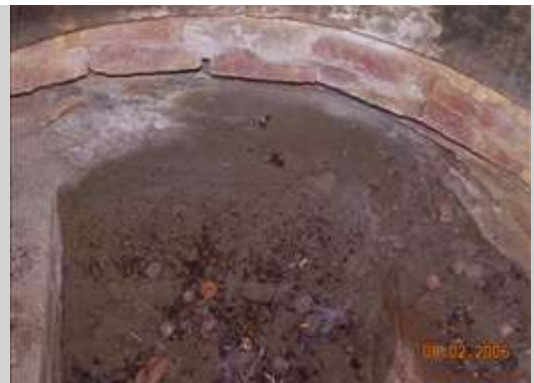
## Pipe Out @ 12 O'Clock

Comments **The O12 is cemented shut - there still appears to be infiltration.**

Cemented pipe.

Pipe Material: ☐ Pipe Lined  
Invert Depth: (ft.) Flow Characteristics: **None**  
Deposits: ☐ None ☒ **Mud** ☐ Sludge ☐ **Debris** ☐ Grease  
Silt Depth: **2** (in.) Deposits Extent: **Light**  
Infiltration: **None** Pipe Seal Cond: **Unknown**

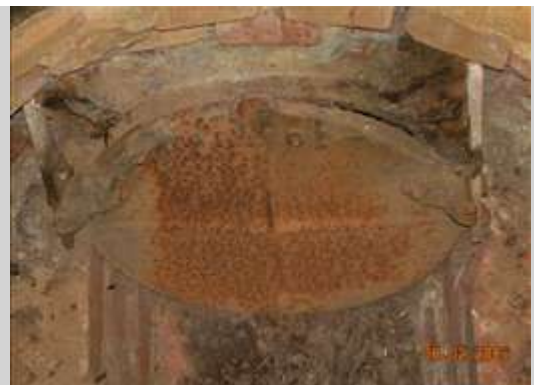
## Pipe In @ 6 O'Clock

Pipe Material: ☐ Pipe Lined  
Invert Depth: (ft.) Flow Characteristics: **None**  
Deposits: ☐ None ☒ **Mud** ☐ Sludge ☒ **Debris** ☐ Grease  
Silt Depth: **1** (in.) Deposits Extent: **Light**  
Infiltration: **Evidence** Pipe Seal Cond: **Unknown**
